RMI Ports Authority

2006 Pacific Aviation Directors Workshop

Majuro Runway Rehabilitation Project

Construction Progress

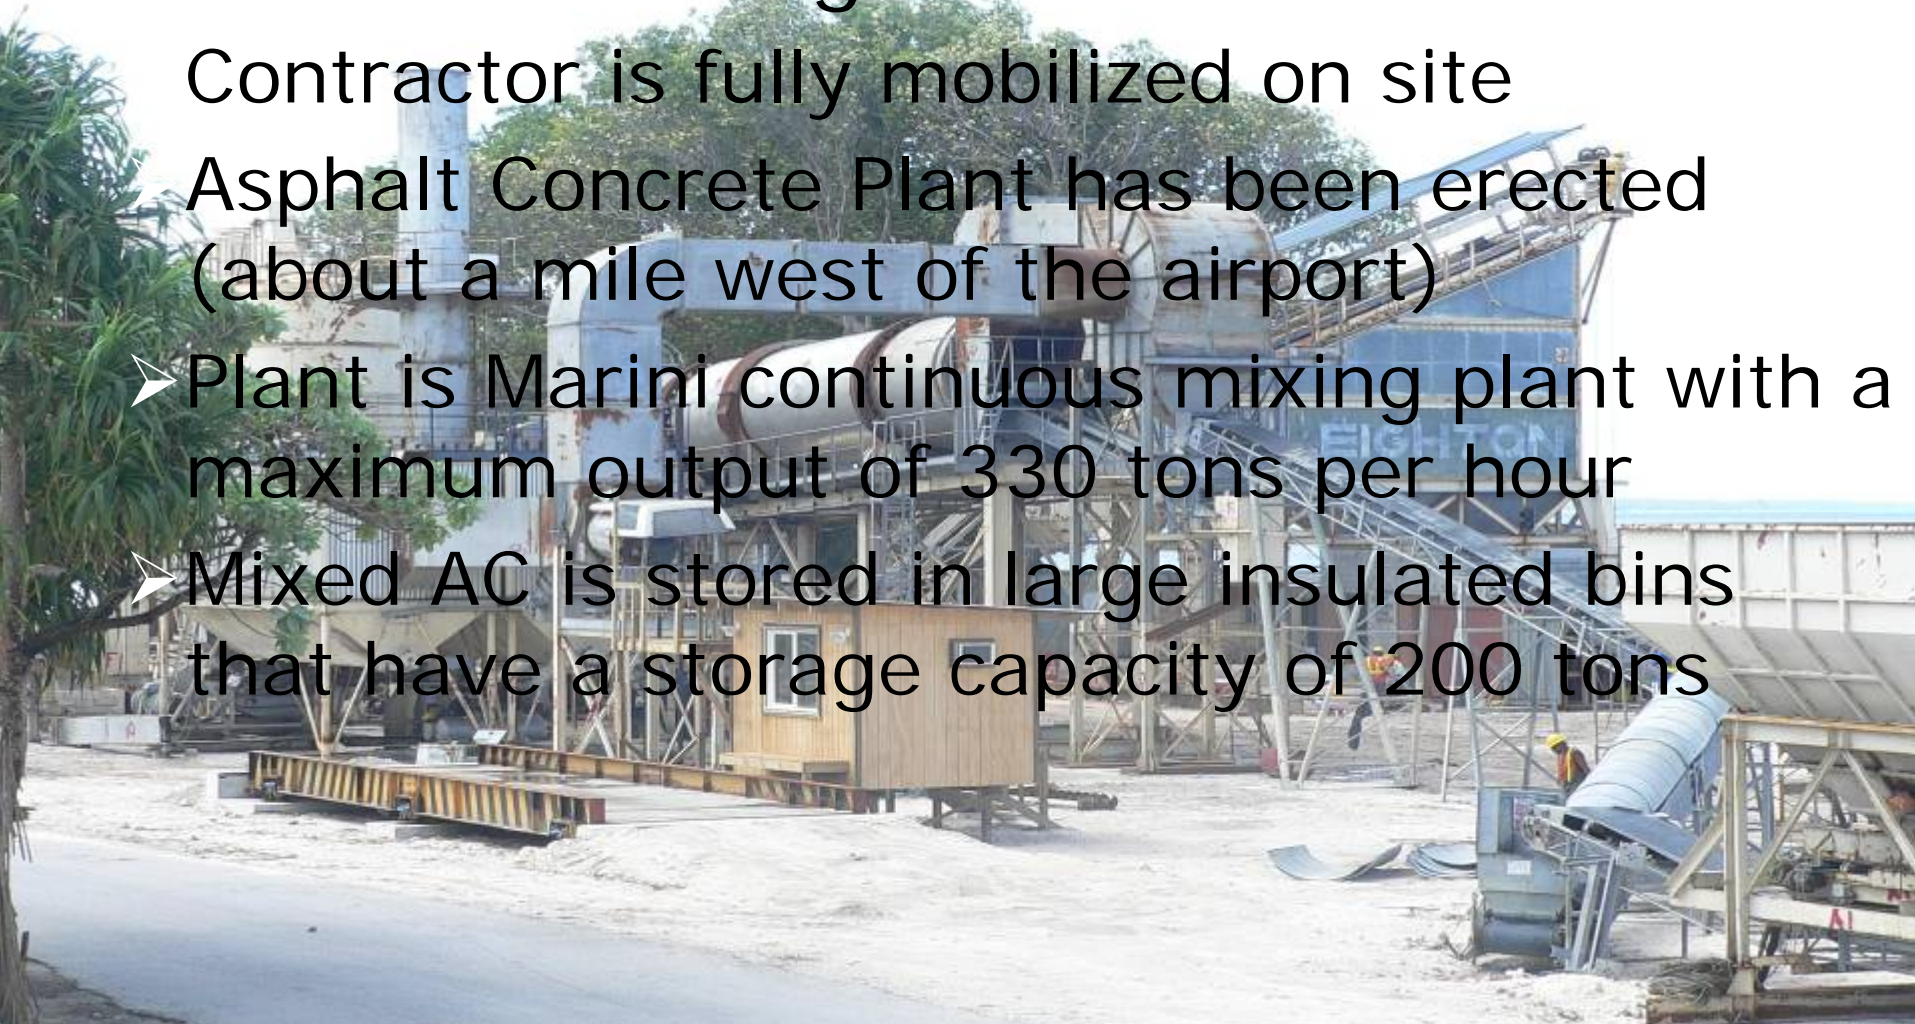
Asphalt Concrete (AC) Plant

Asphalt Concrete Plant has been erected (about a mile west of the airport)

- Plant is Marini continuous mixing plant with a maximum output of 330 tons per hour
- Mixed AC is stored in large insulated bins that have a storage capacity of 200 tons

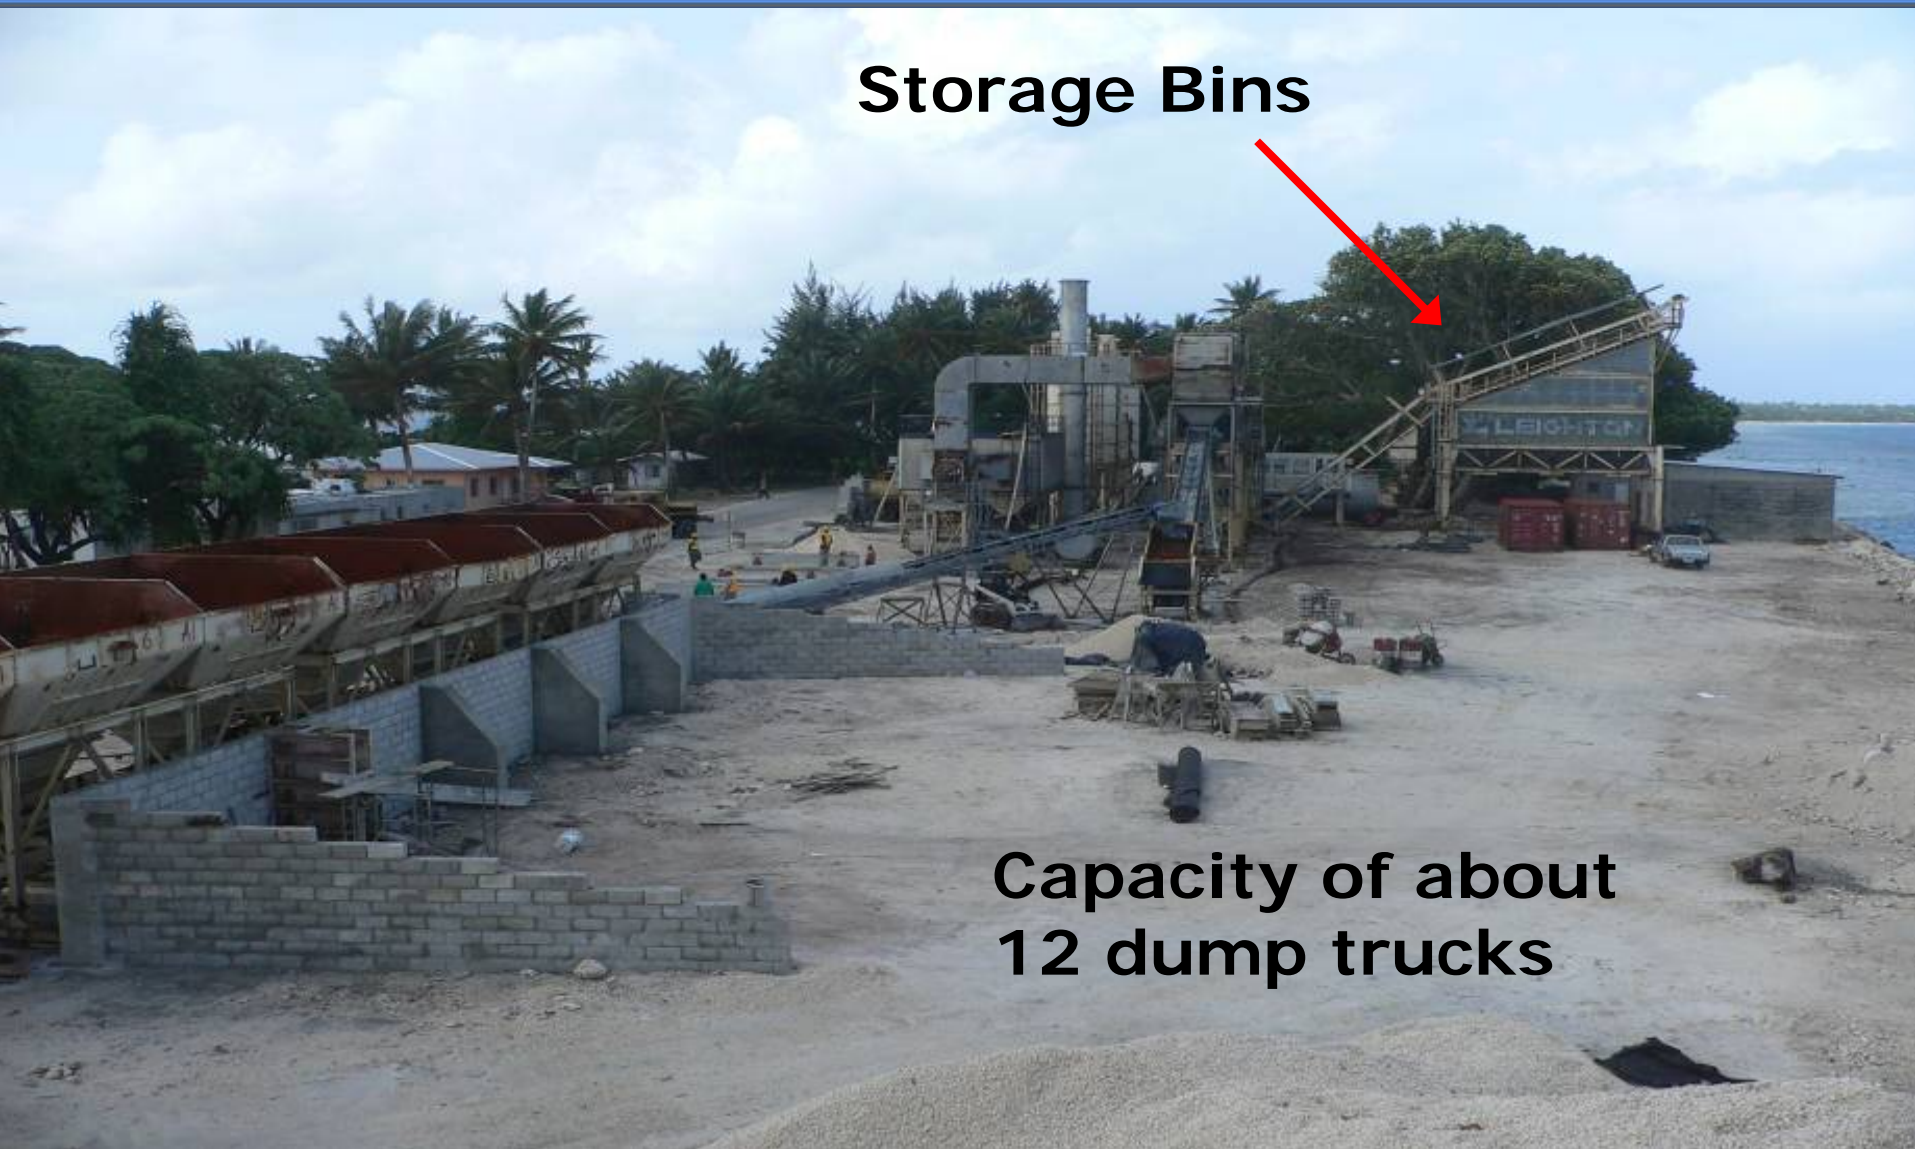
Storage Bins

**Capacity of about
12 dump trucks**

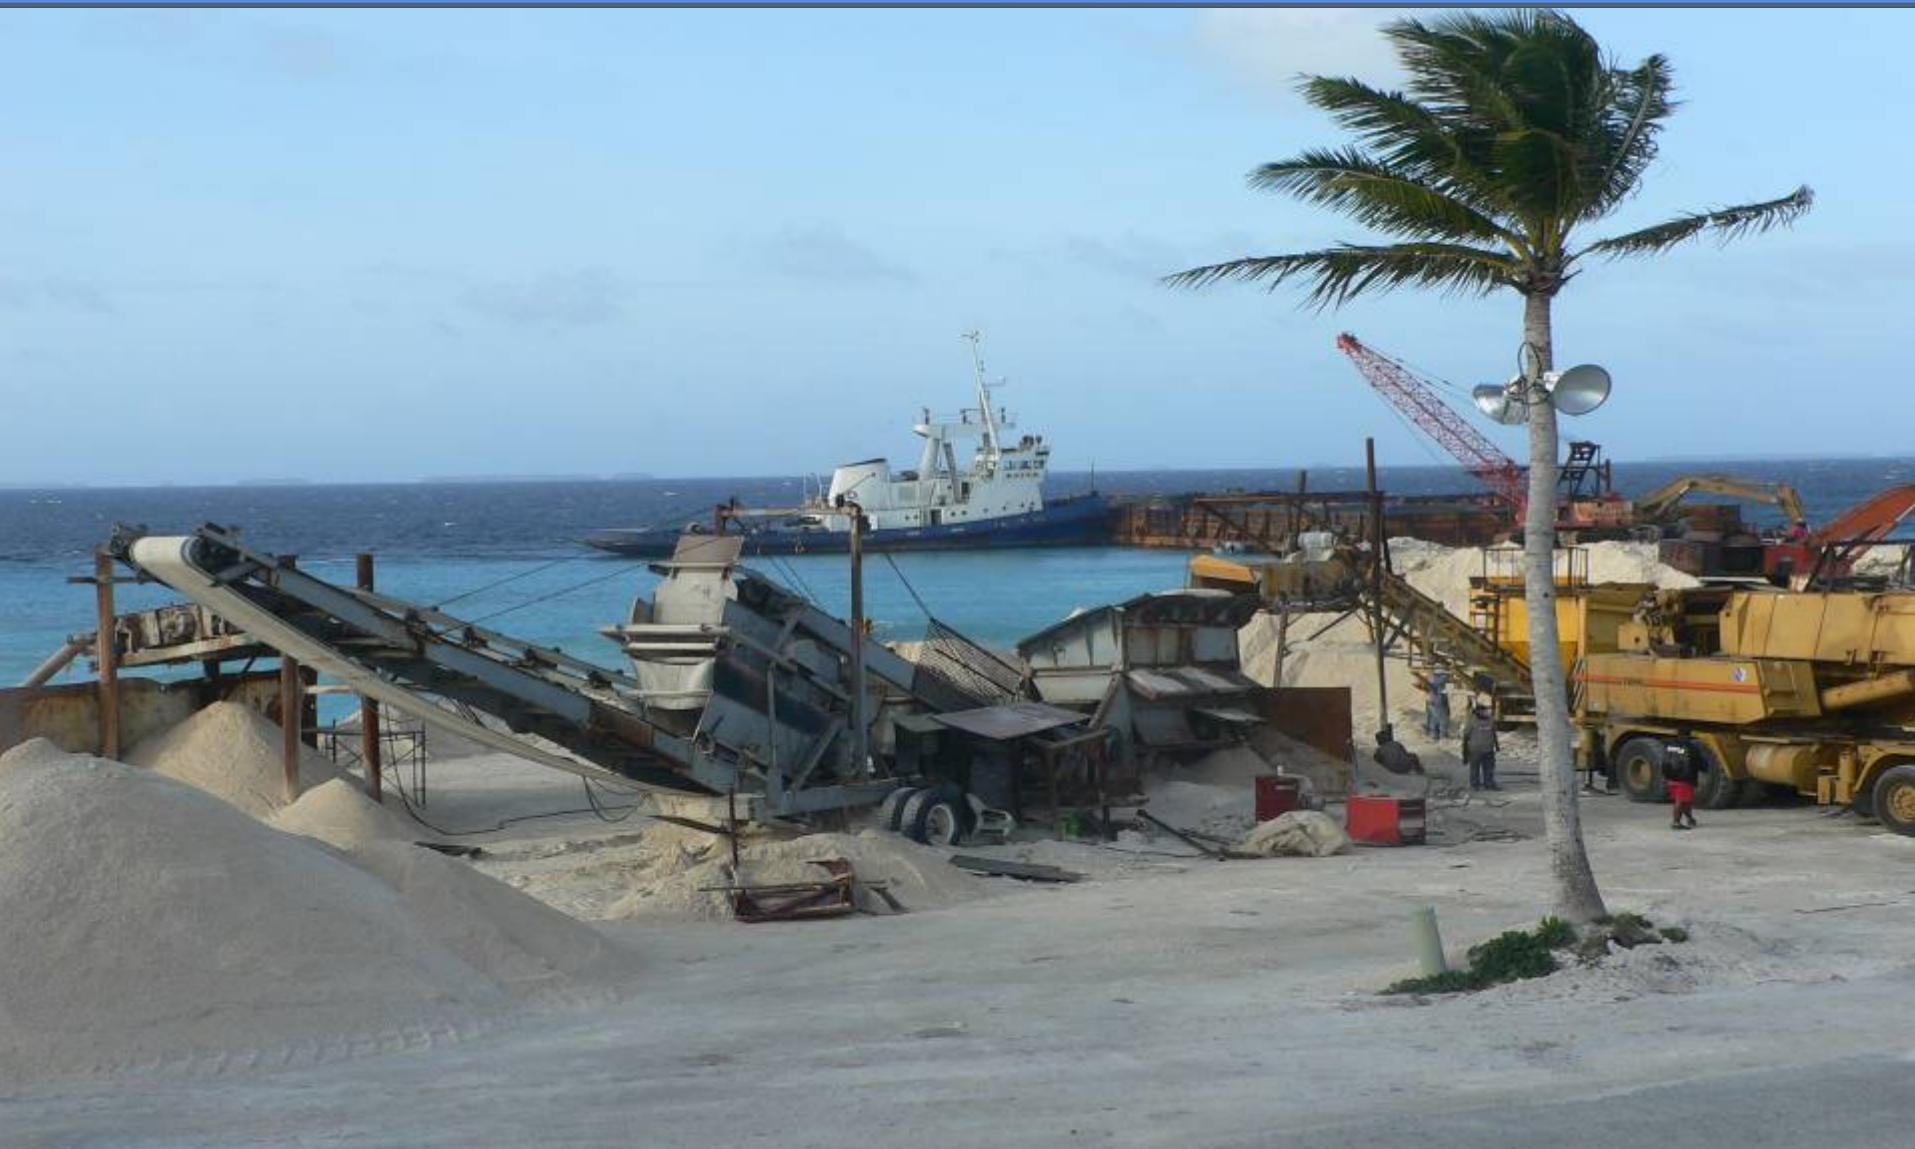
Stockpiling Area

- 61% of aggregates used on the runway project will be imported
- 39% will be produced locally

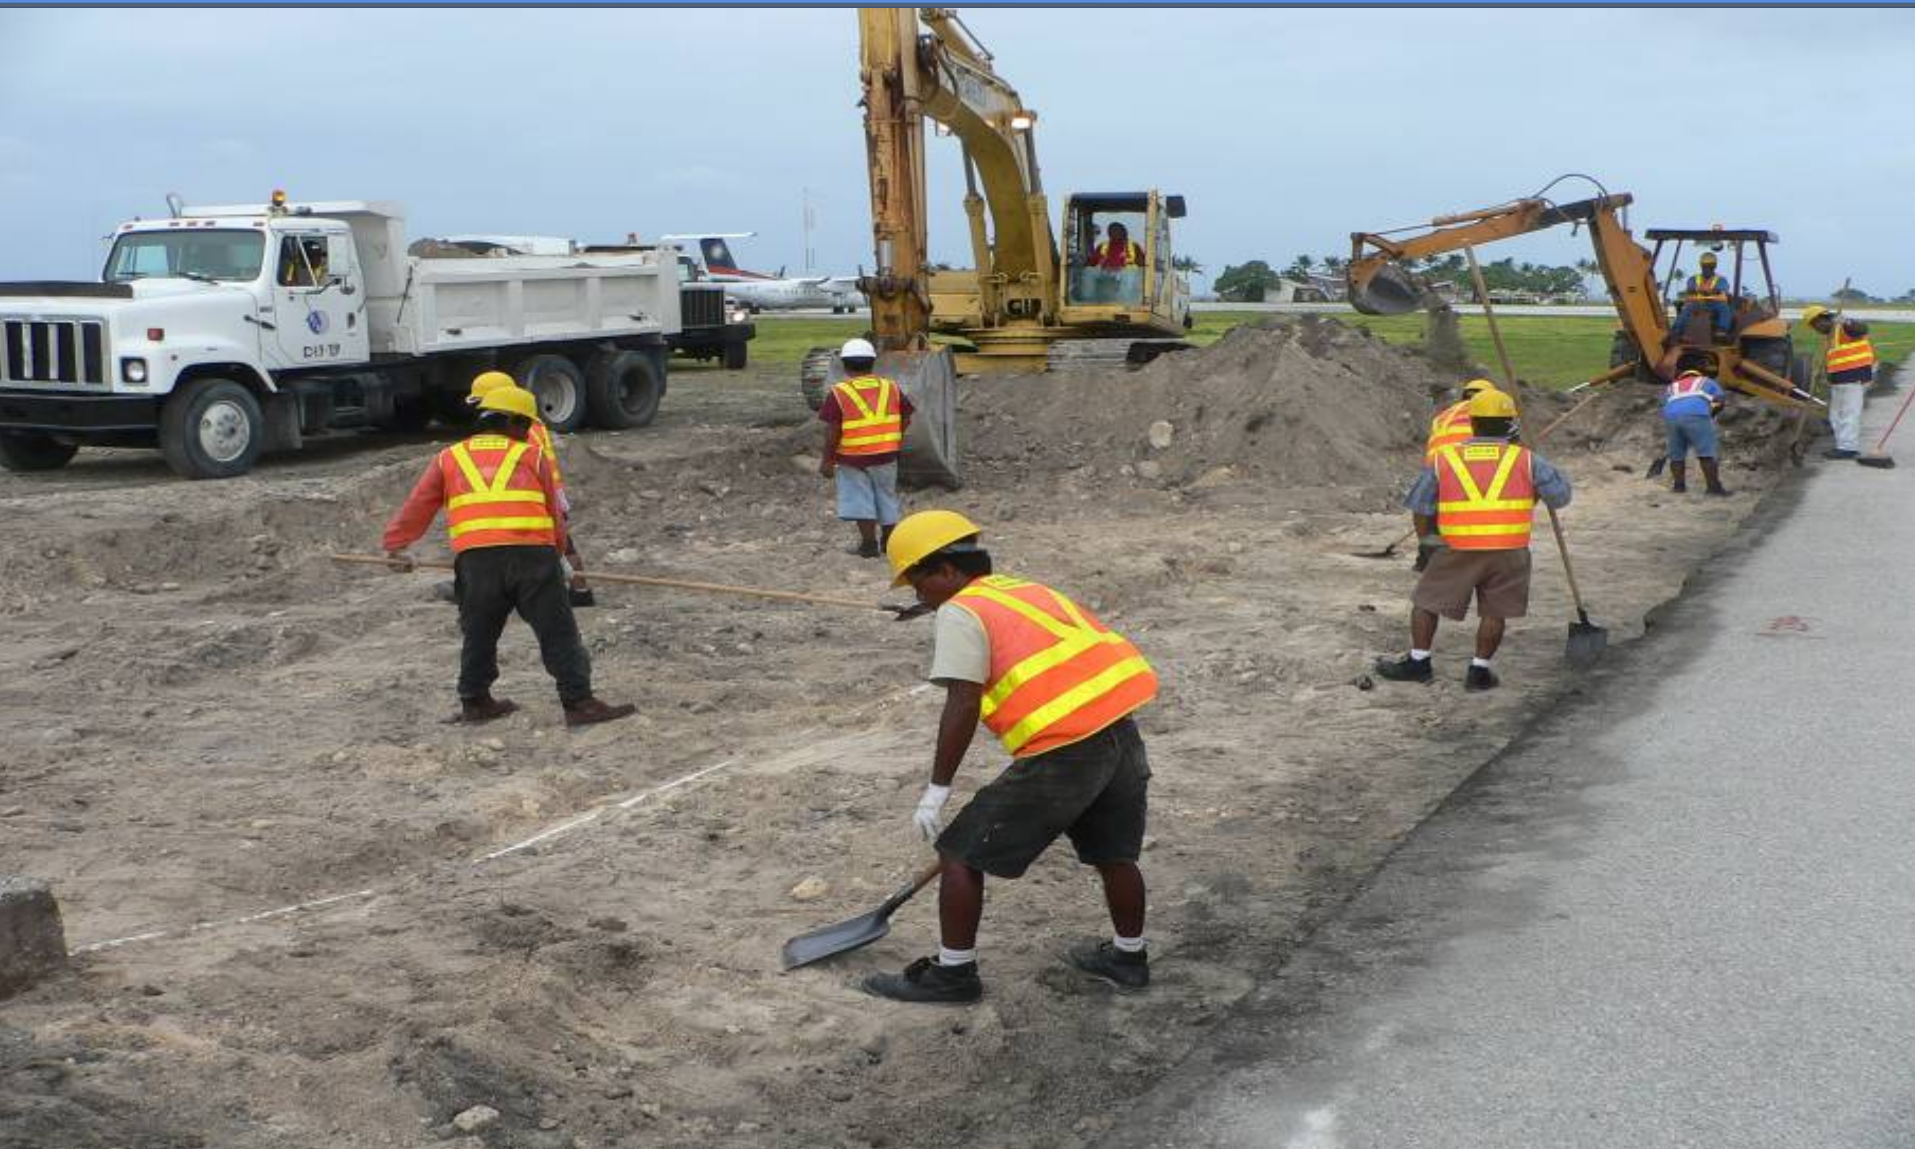
New Runway Shoulder

- Area Constructed: 675' long x 25' wide
- Excavation Depth: 20" (10" subbase, 8" basecourse and 2" AC)
- Status: Completed

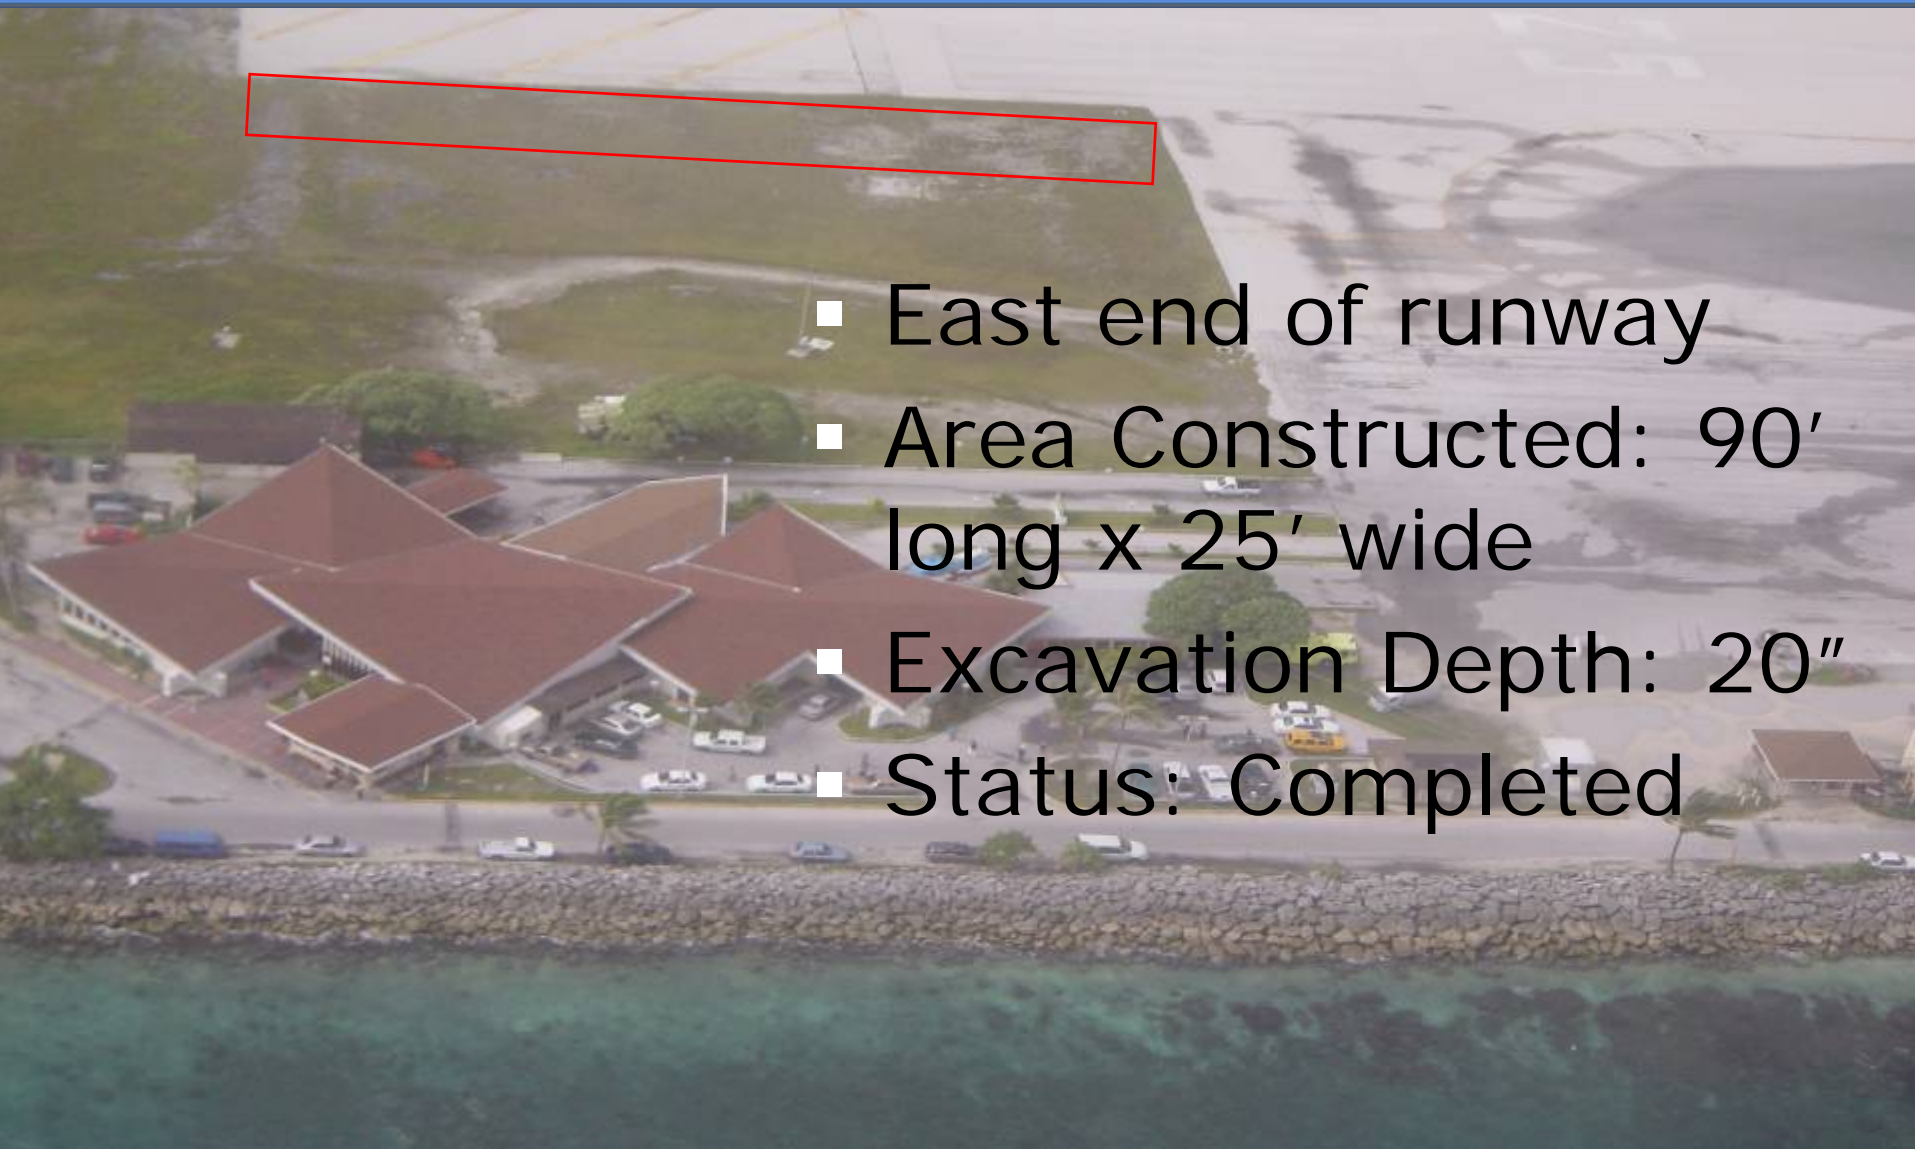
Additional Shoulder – RNWY 25

- East end of runway
 - Area Constructed: 90' long x 25' wide
 - Excavation Depth: 20"
 - Status: Completed

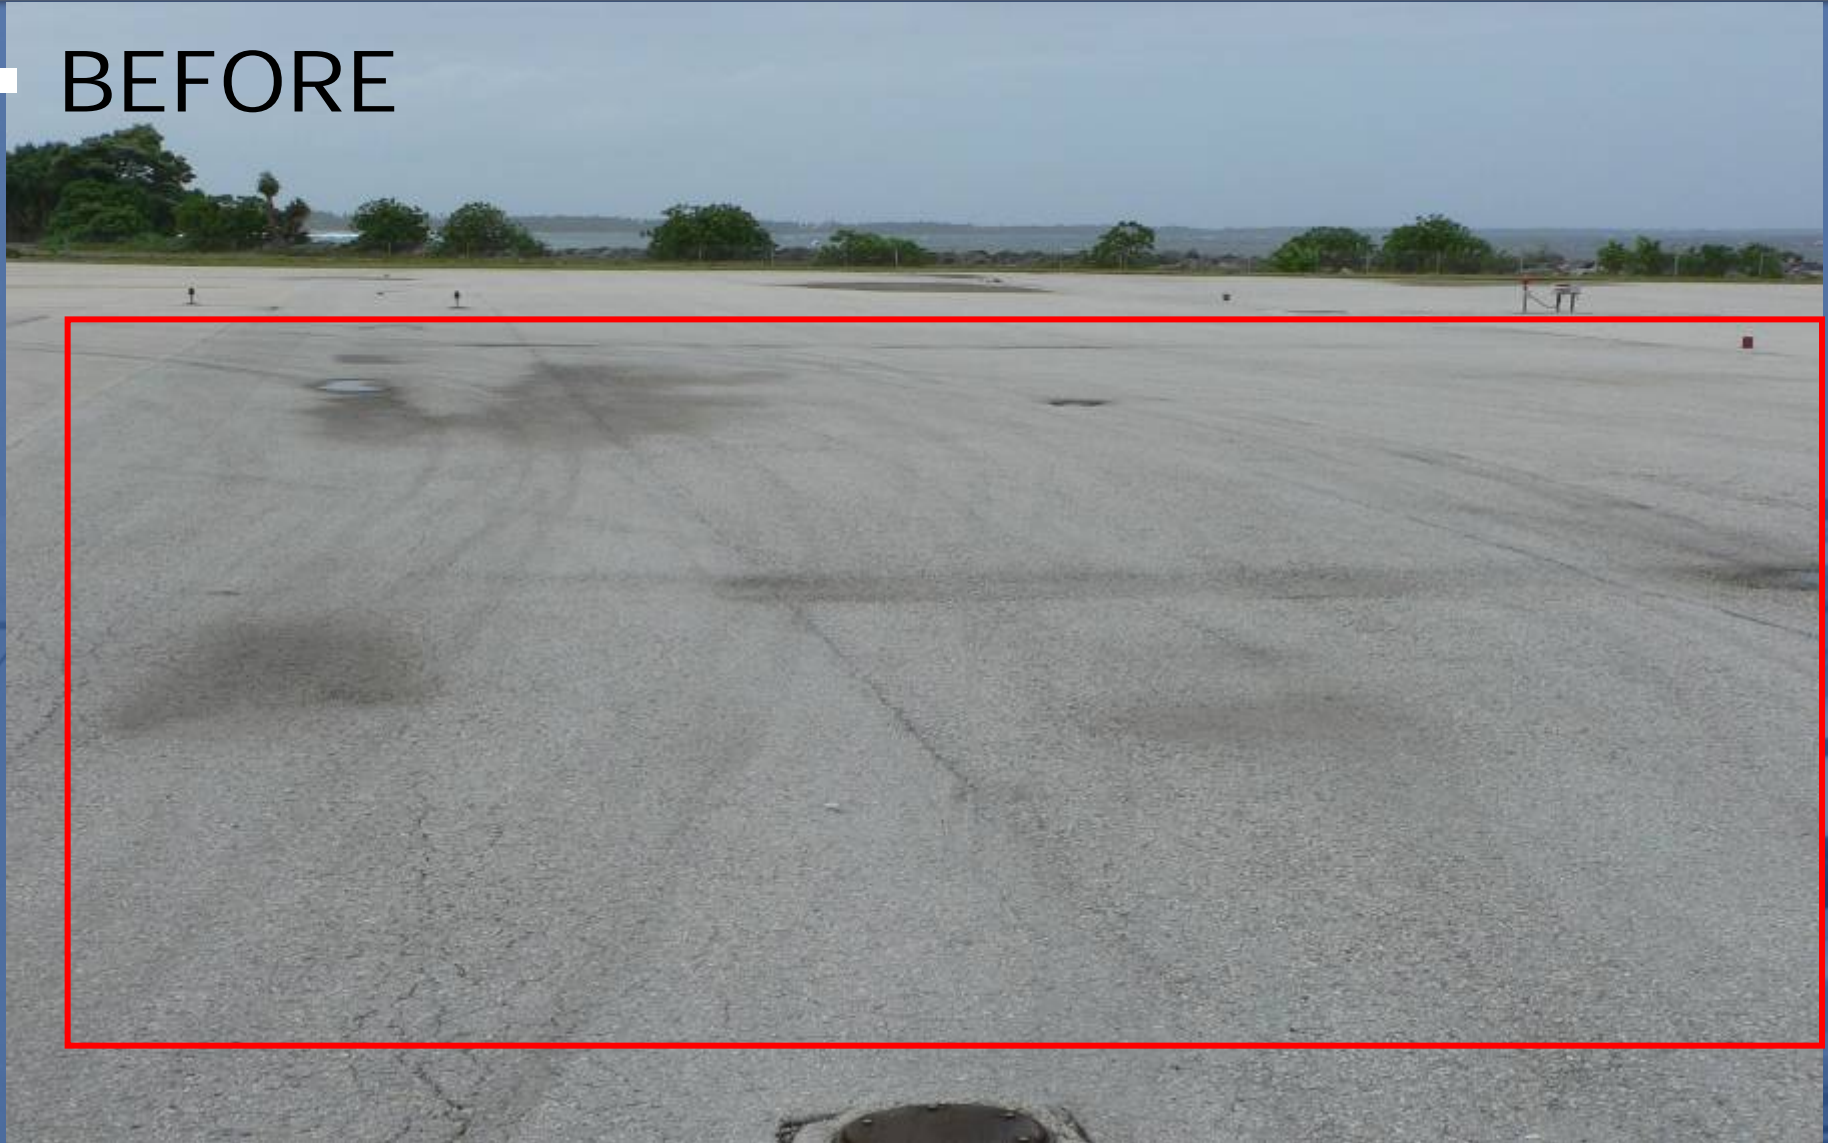
Turnaround Bay – Runway 07

■ BEFORE

- Area Constructed: 330' long x 40' wide
- Excavation depth: 20" (10" subbase, 8" basecourse, 2" AC)
- Additional 3" asphalt will be applied during overlay works

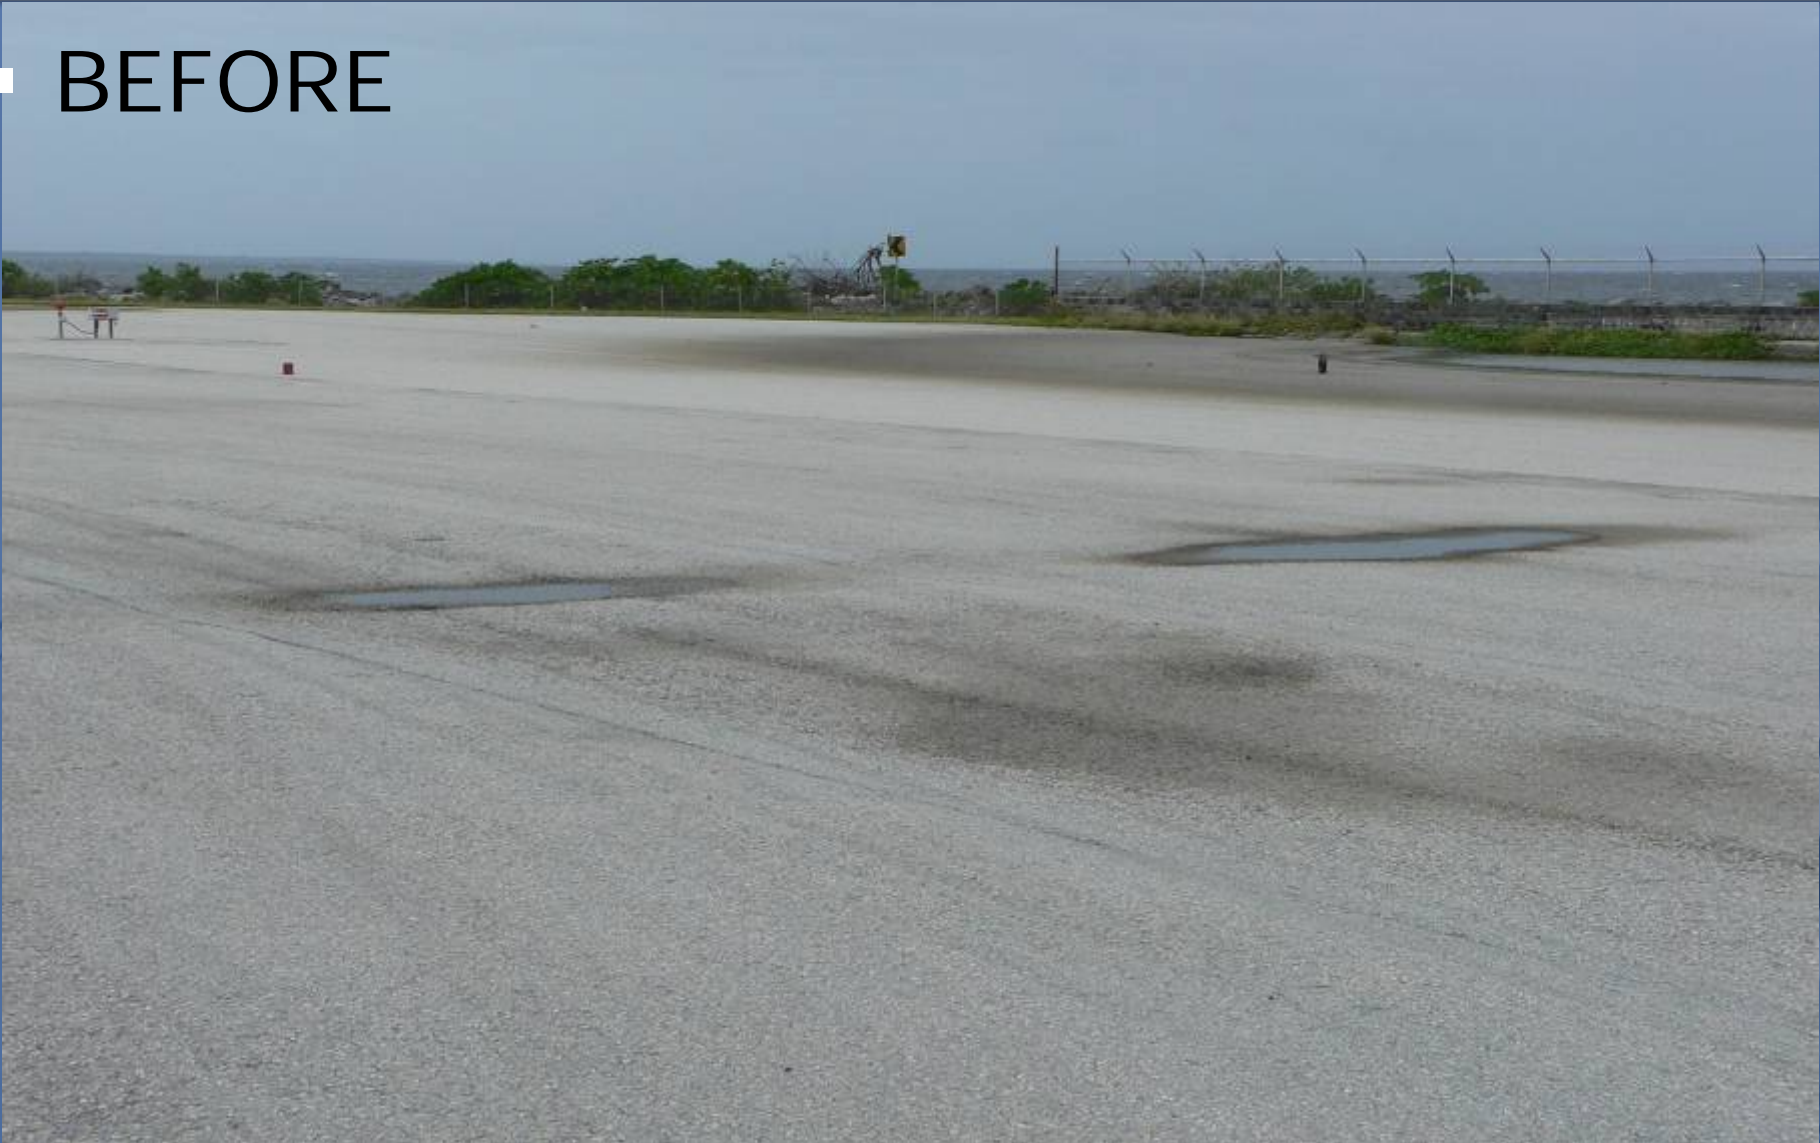
Turnaround Bay – Runway 7

- BEFORE

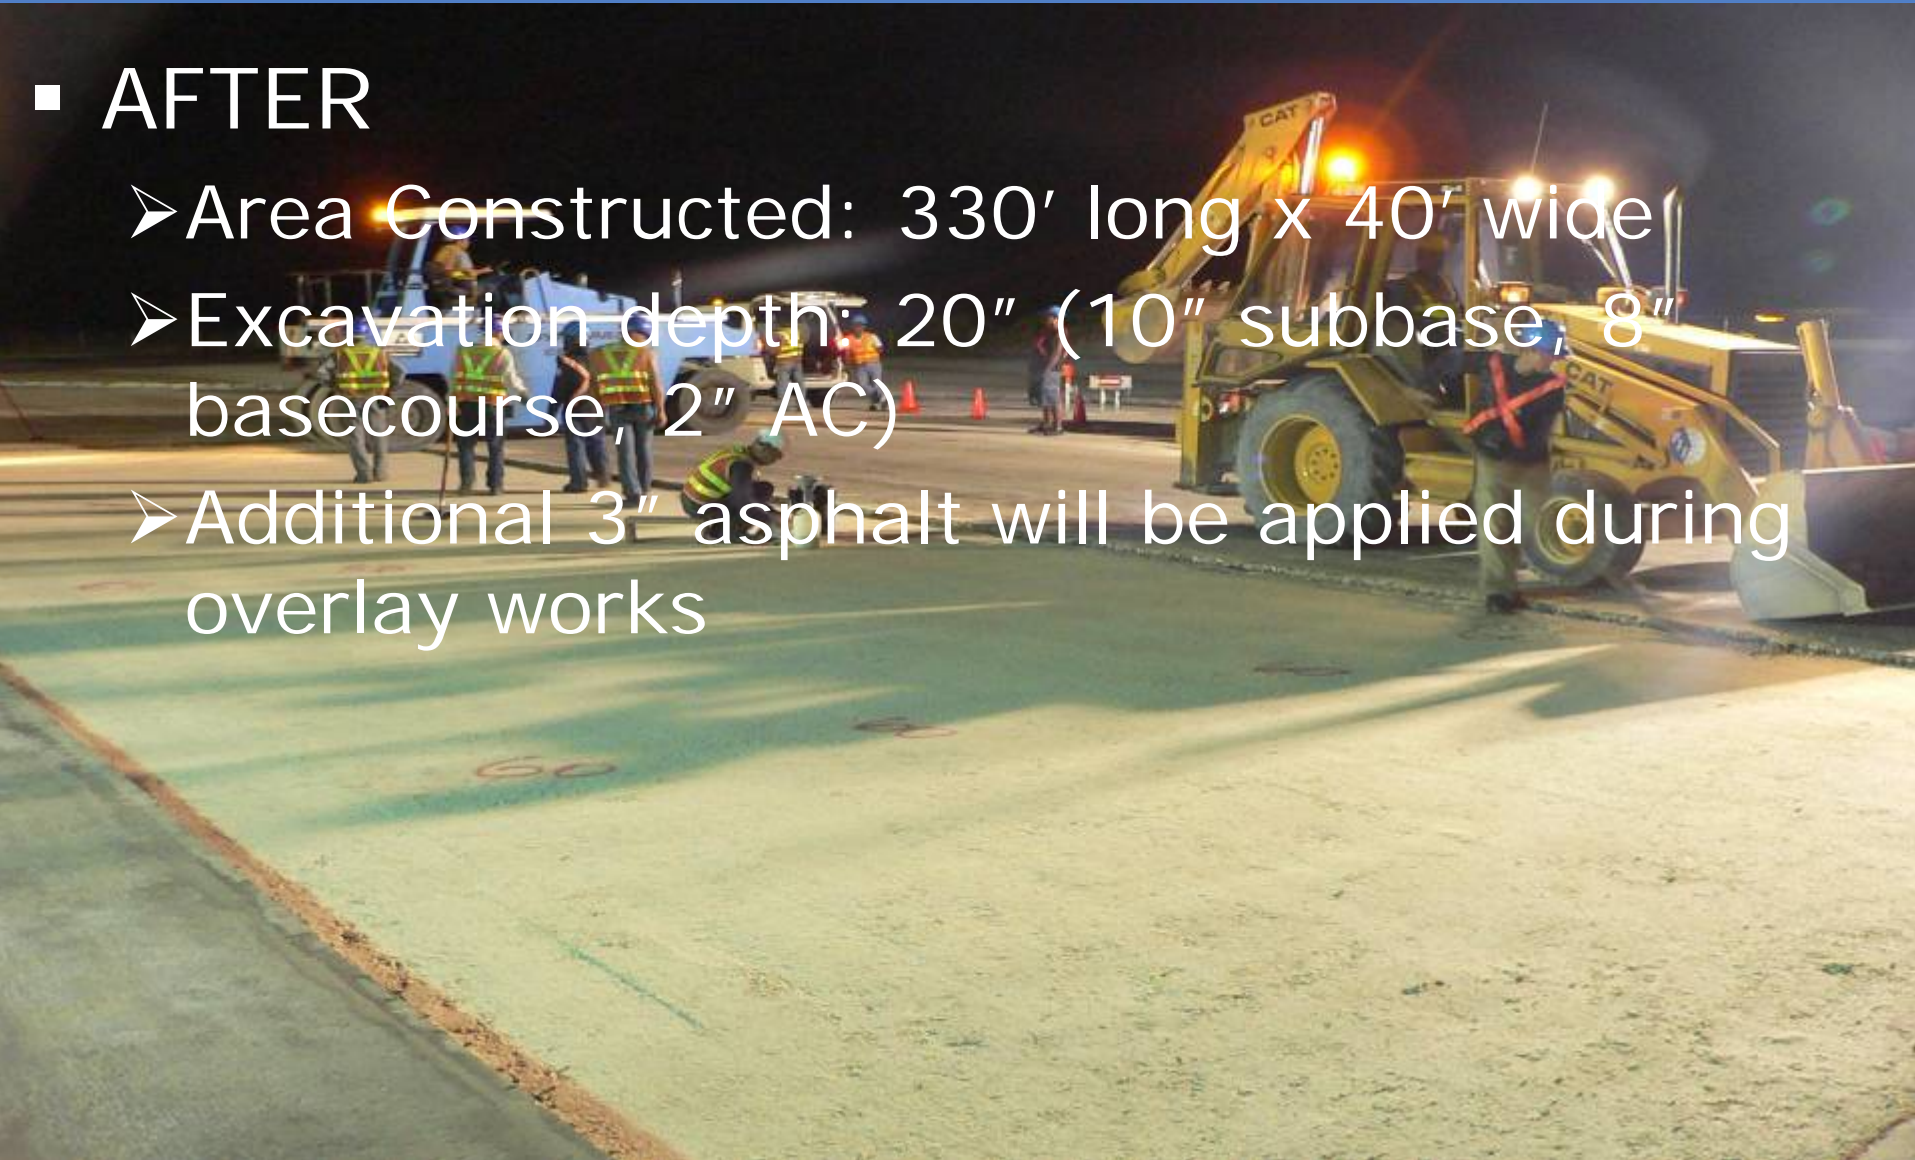
Turnaround Bay – Runway 07

■ AFTER

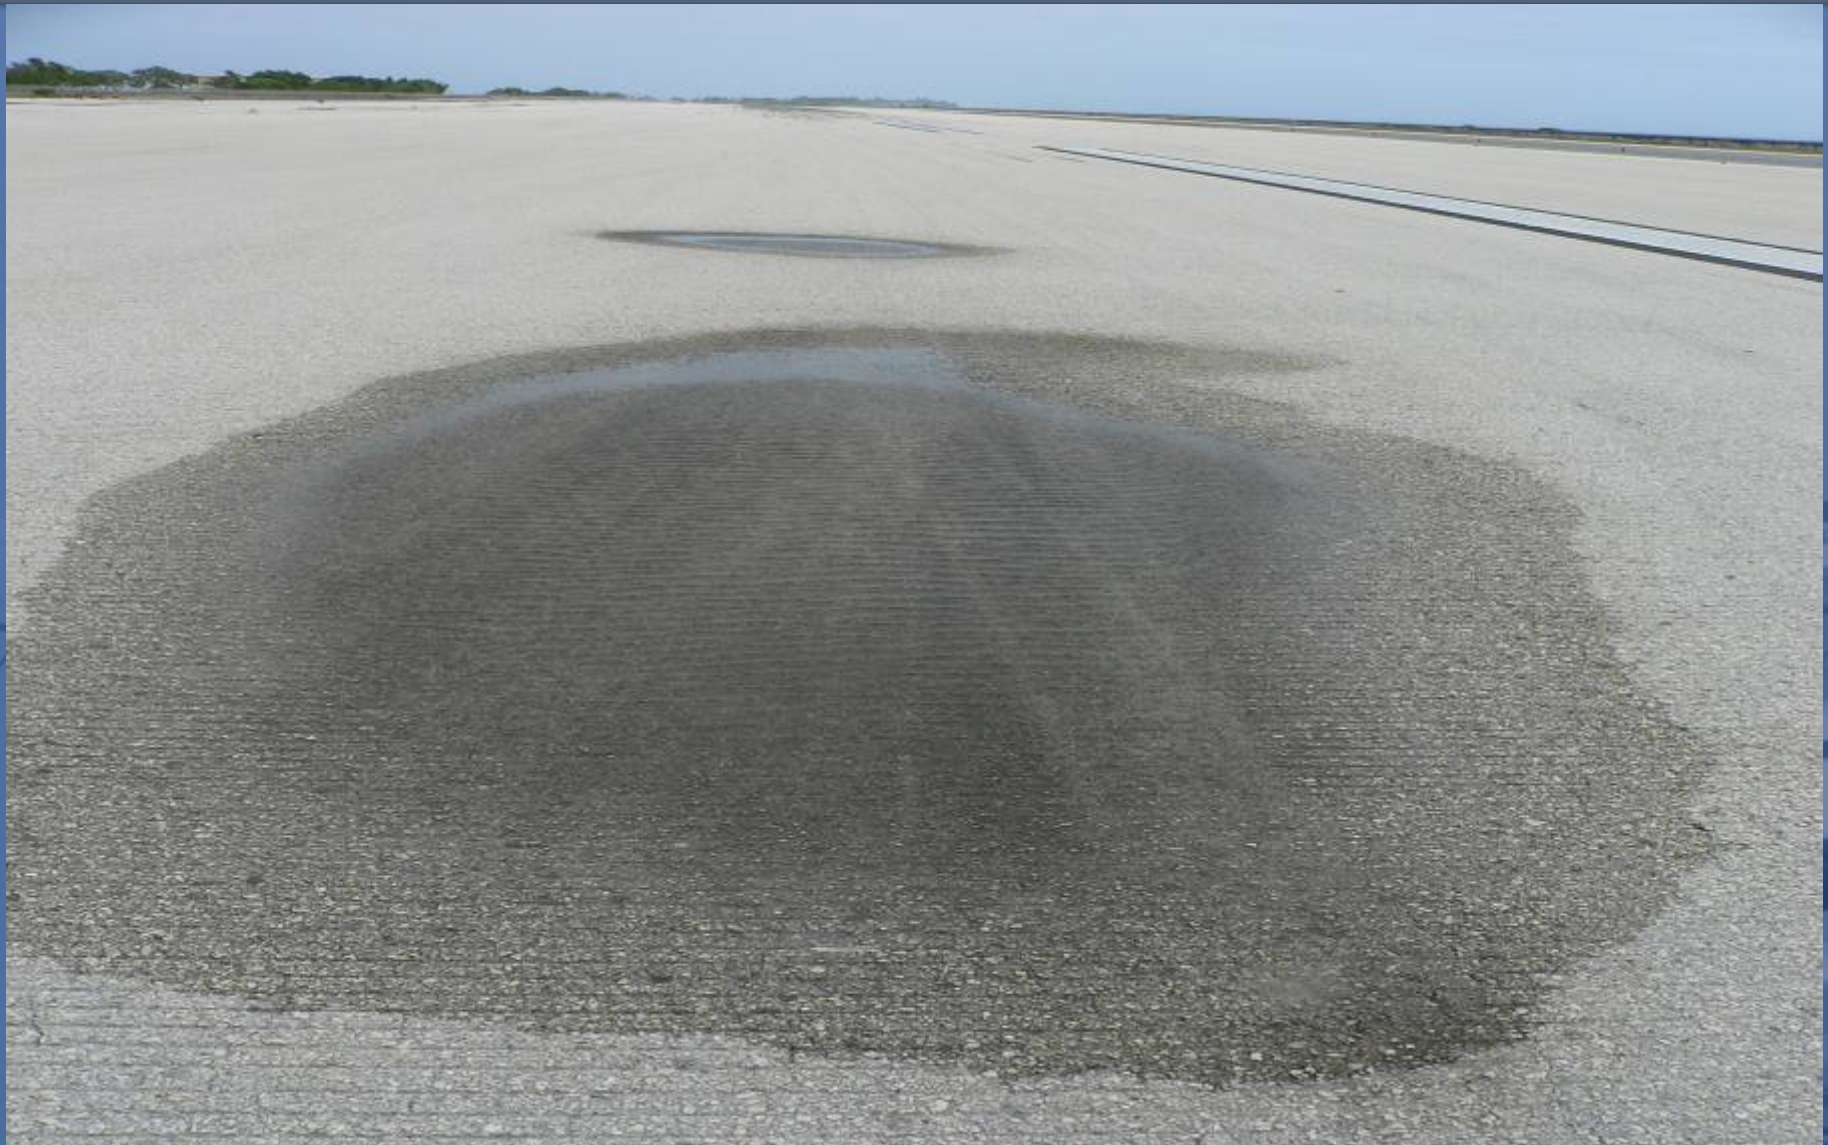
Pavement Rutting

- Area is deteriorating rapidly and requires immediate remedial work to prevent spalling, in which the surface breaks up under loading and generates loose stones and chunks of asphalt

- Areas with rutting problems were excavated and reconstructed prior to asphalt overlay
- This was necessary to ensure that the areas do not continue to rut in the future

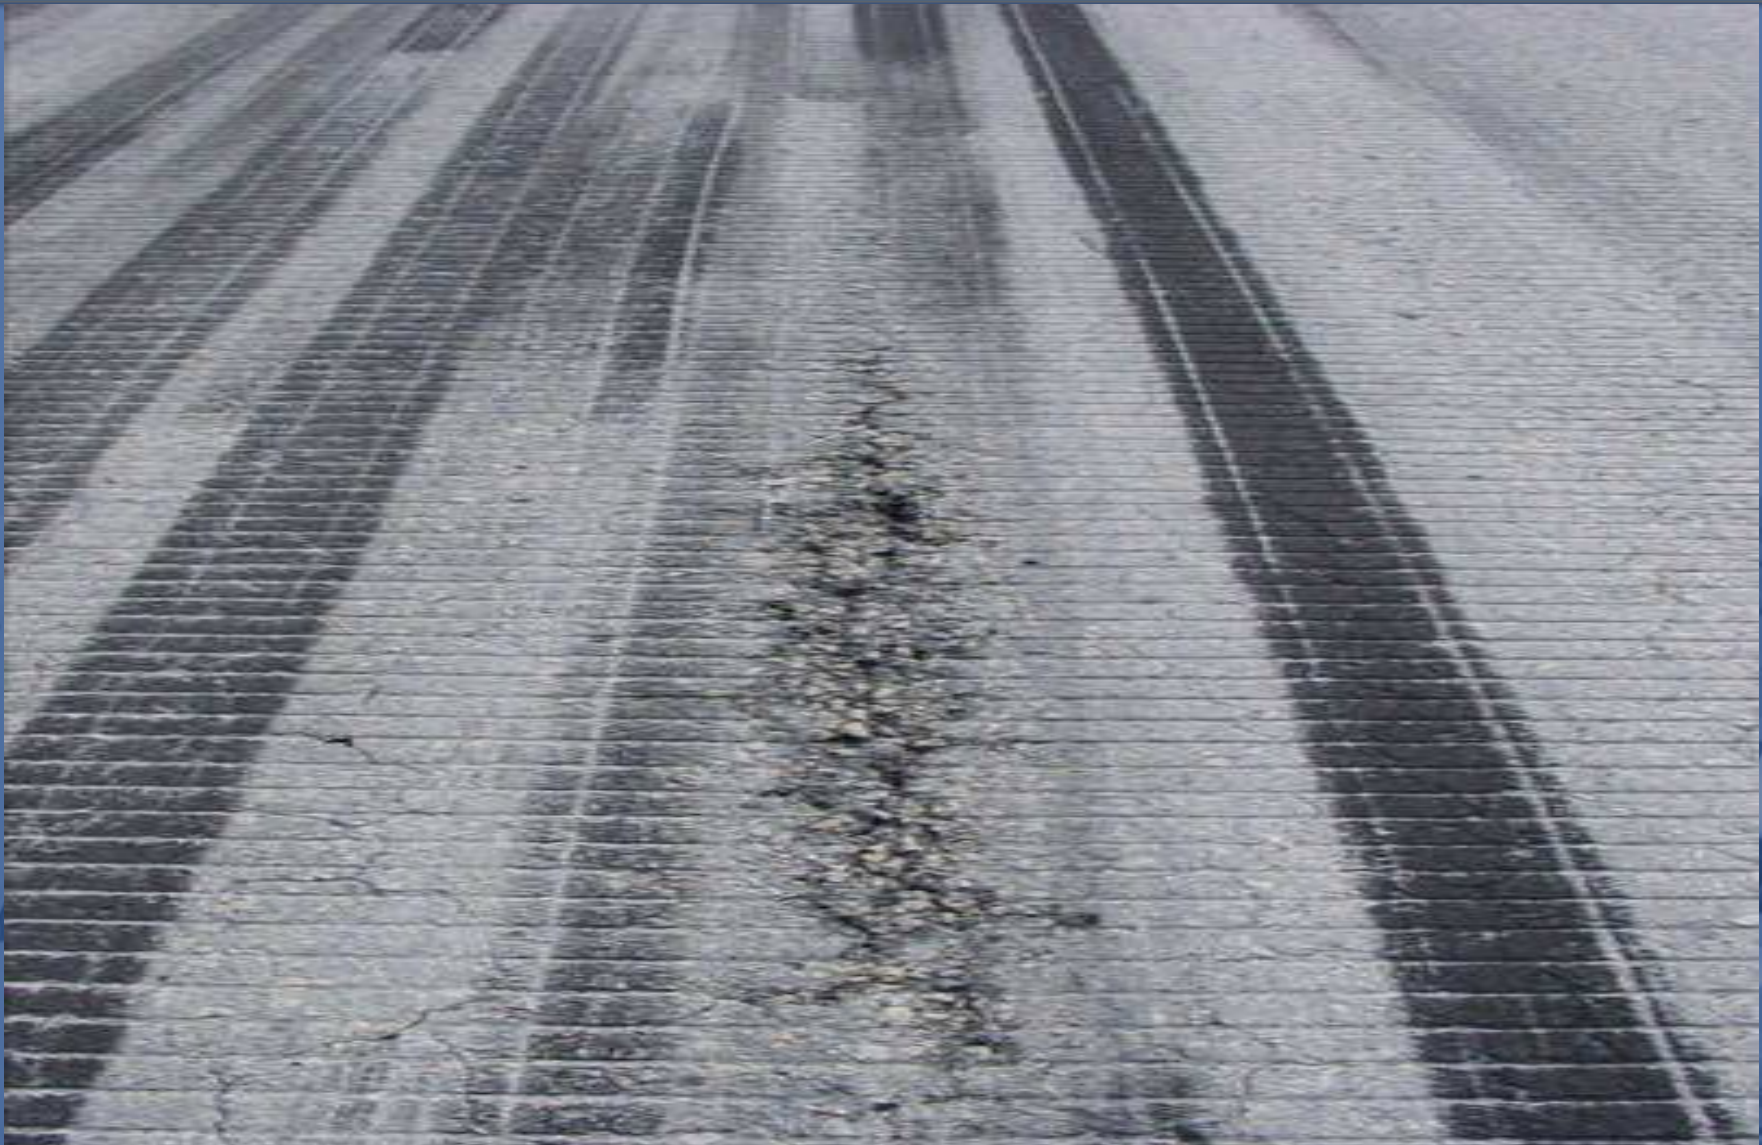
Severe raveling on Runway 7

- For areas with severe raveling and cracking problems, contractor milled out a minimum of 50mm (2 inches) of the existing AC surface and replaced it with new AC prior to the new overlay surface
- If left untreated, the existing large cracks have the potential to reflect through the new AC overlay within 3-5 years
